NAVSWC TR 90-176

**USS PRINCETON (CG 59): MICROBIOLOGICALLY
INFLUENCED CORROSION (MIC) AND
MACROFOULING STATUS OF SEAWATER
PIPING SYSTEMS**

1 JUNE 1990

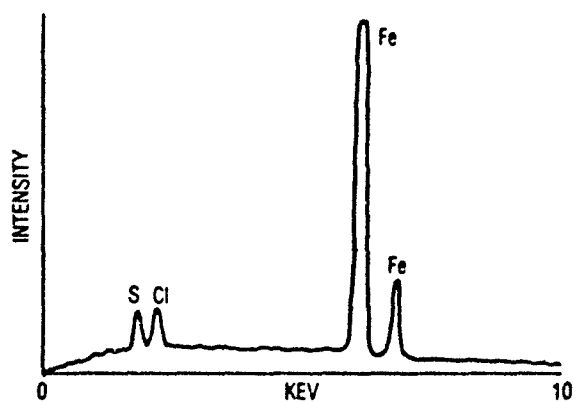
FIGURE 1. EDAX SPECTRUM OF THE BLACK DEPOSIT REMOVED FROM THE WASTER PIECE OF THE #6 MAIN SEA CHEST (SRB WERE ISOLATED FROM THIS DEPOSIT)

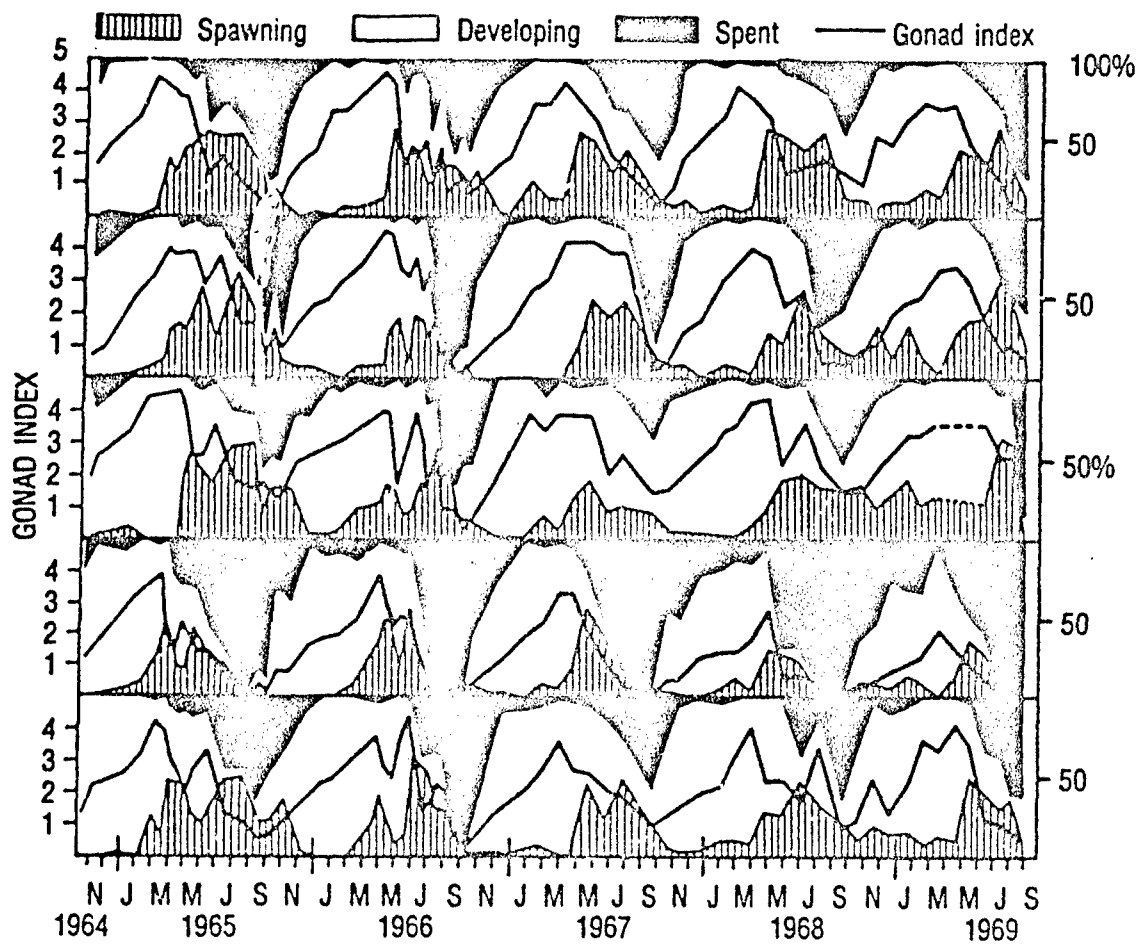
FIGURE 2. GONAD INDEX AND PERCENTAGE DISTRIBUTION OF SPAWNING, DEVELOPING AND SPENT MARINE MUSSELS (*MYTILUS EDULIS*) IN FIVE POPULATIONS OVER A FIVE YEAR TIME PERIOD (FROM SEED, 1975)⁹¹

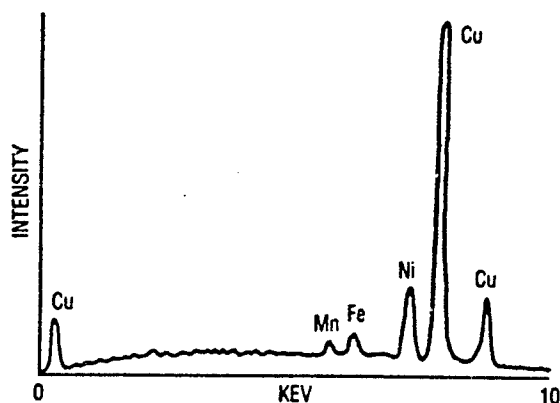
FIGURE 7. EDAX SPECTRUM FOR THE BASE METAL (90:10 COPPER-NICKEL) OF THE AFT MASKER COOLING DISCHARGE PIPING REMOVED FROM CG 59

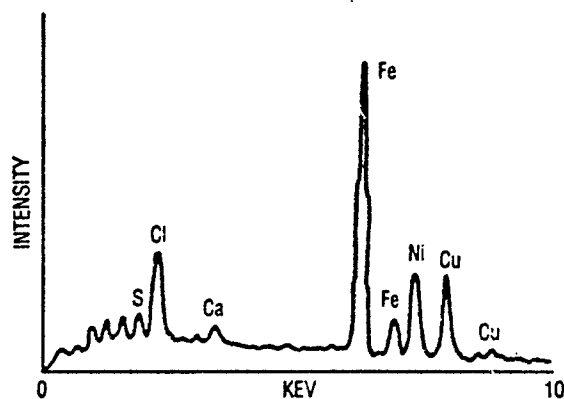
FIGURE 8. EDAX SPECTRUM WITHIN A PIT IN THE AFT MASKER COOLING DISCHARGE PIPING (90:10 COPPER-NICKEL) REMOVED FROM CG 59 SHOWED AN ENRICHMENT FOR IRON AND CHLORINE COMPARED TO THE BASE METAL

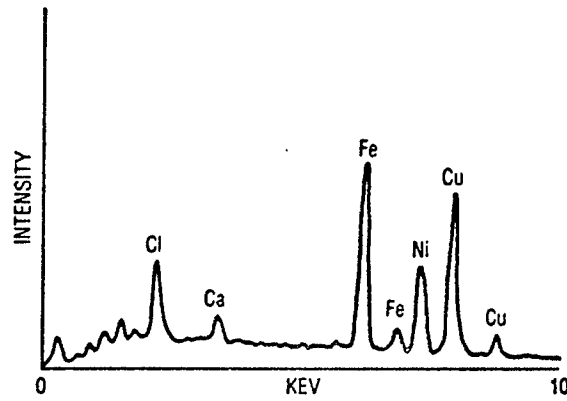
FIGURE 9. EDAX SPECTRUM FOR A BLACKENED AREA ON THE AFT MASKER COOLING DISCHARGE PIPING SHOWED HIGHER LEVELS OF IRON, NICKEL, CHLORINE AND CALCIUM COMPARED TO THE EDAX SPECTRUM FOR THE BASE ALLOY

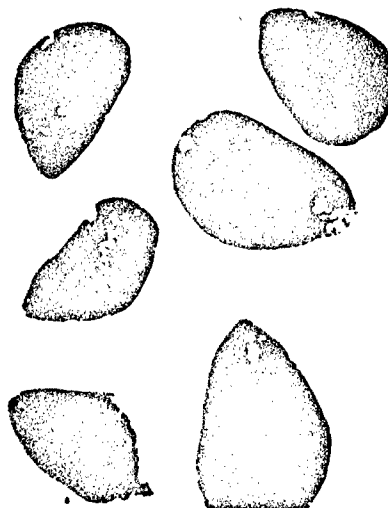
FIGURE 13. INTACT MARINE MUSSEL SHELLS, MYTILUS EDULIS, REMOVED FROM CG 59 SEAWATER PIPING SYSTEMS RANGED IN SIZE FROM APPROXIMATELY 8MM X 11MM (TWO WEEKS OLD) UP TO 17MM X 30MM (TWO MONTHS OLD)

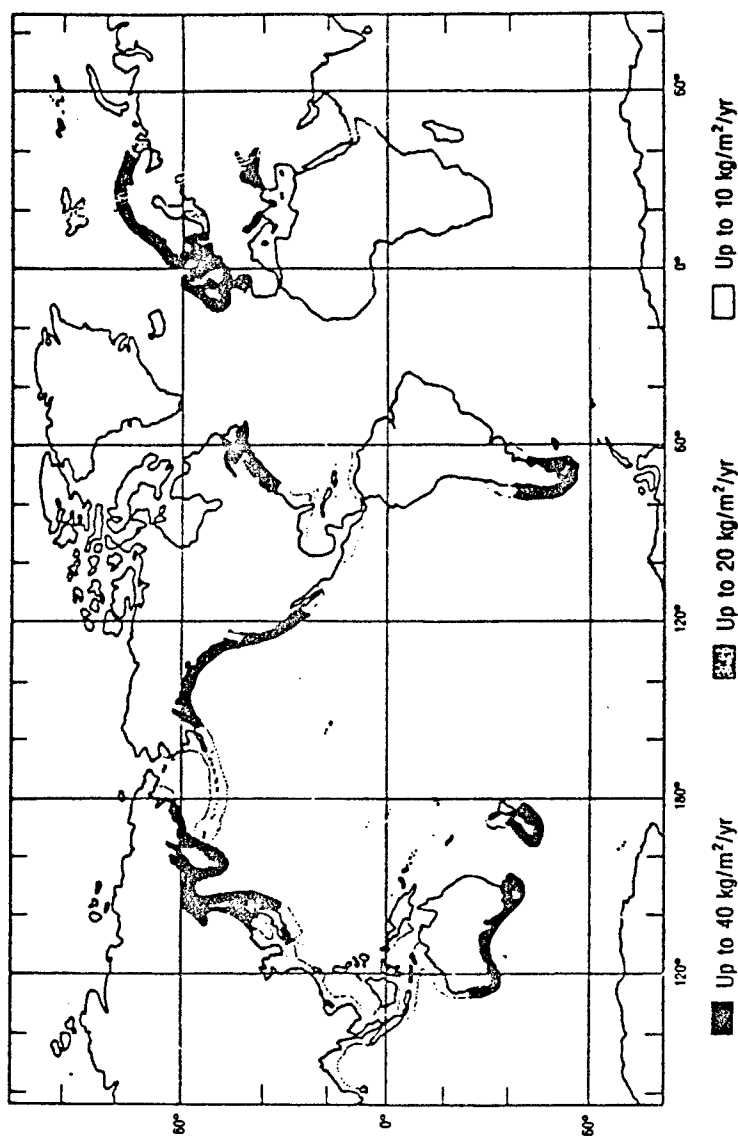
FIGURE 14. DISTRIBUTION OF MYTILUS MUSSEL BEDS SHOWN HERE INDICATES THAT MUSSEL FOULING CONDITIONS ARE MORE SEVERE IN HIGH AND MIDDLE LATITUDES WHERE THESE MUSSELS ARE THE DOMINANT FOULING SPECIES (FROM LITTLE AND DEPALMA, 1998)¹⁸

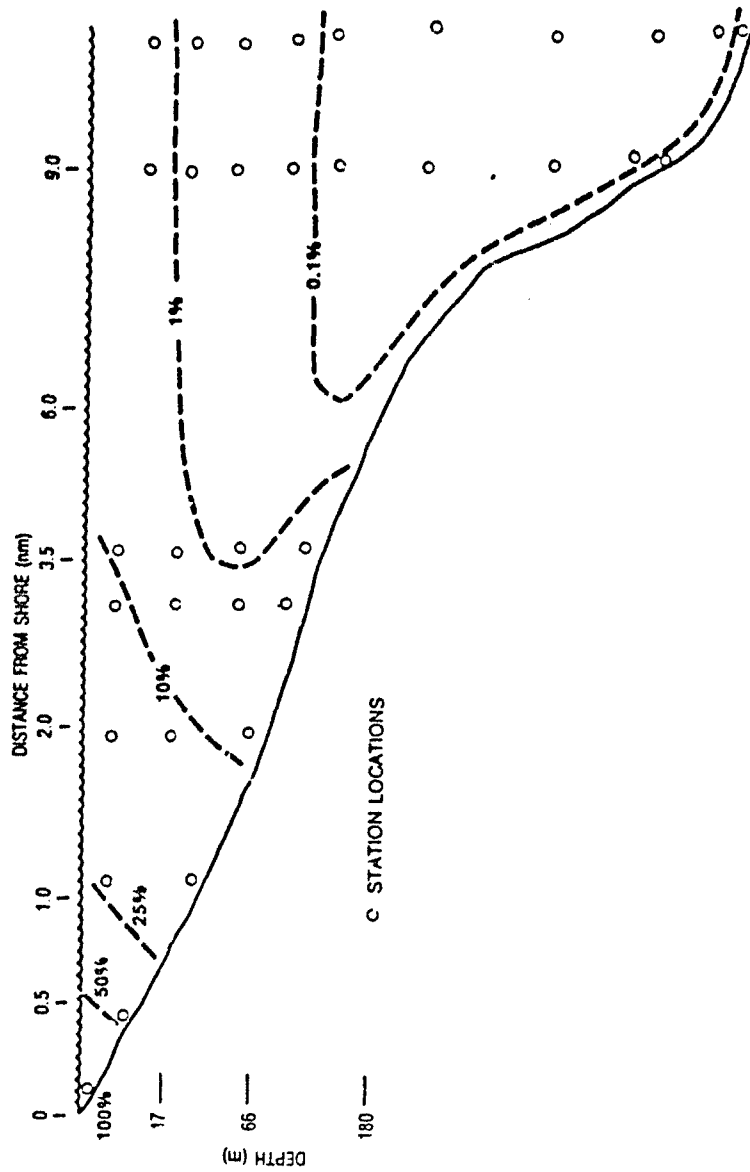
FIGURE 15. NUMBER OF MYTILUS MUSSELS THAT COULD CAUSE FOULING PROBLEMS DECREASES WITH THE DISTANCE FROM THE SHORE (FROM LITTLE AND DEPALMA, 1988)¹⁸

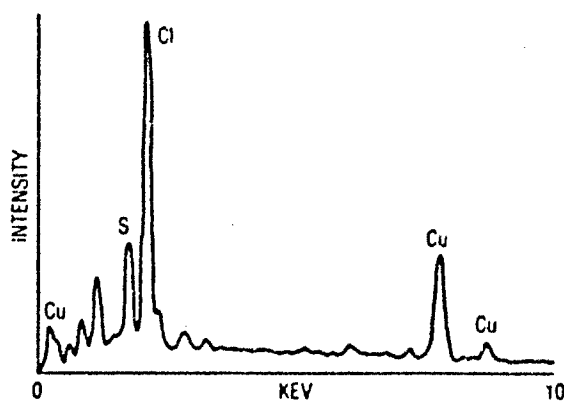
FIGURE 17. EDAX SPECTRUM OF THE HYDROIDS REMOVED FROM CG 59 SEAWATER PIPING SYSTEMS SHOWED LARGE AMOUNTS OF CHLORINE, COPPER AND SULFUR
